Detailed Seismic Assessment Commercial Building

Location: 11b Allandale Road, Hawarden 7385
Client: Hurunui District Council

Job No: FC19037
Issue Date: 15 August 2019
Revision: 00

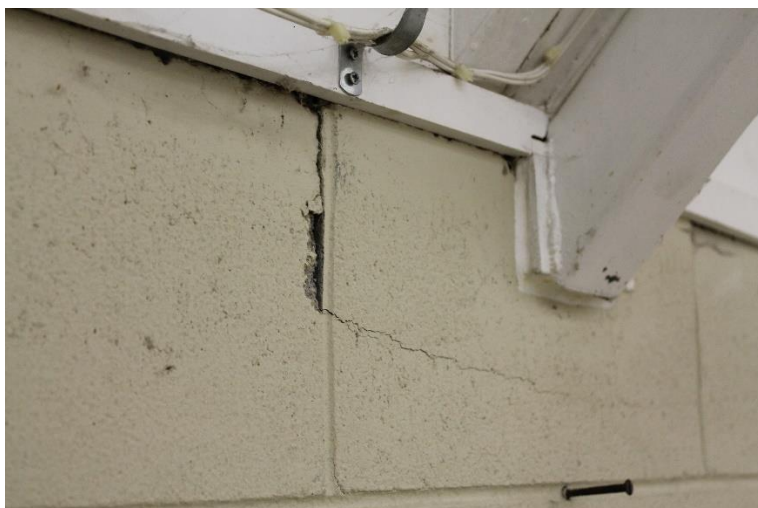
The building has one clear critical structural weakness. This is found at the connection of the squash court roof support to the main building column and masonry wall. There is earthquake damage at this point.

It appears that the addition of the squash court to the main building has changed the structural action of the building. The addition should have improved the structural performance of the building, and where the load transfer is through transverse walls, there is no evidence of damage. The main evidence of damage is where the transfer of horizontal earthquake force is through a single point at the roof rafter. The most likely repair is to strengthen the area of load transfer.

Earthquake Damage Critical Structure weakness – squash court

1. Repair and strengthen the damaged connection in the block wall between the squash court and the main function area
2. Repair the cracks between the block centre wall of the squash court and the pre-cast panels
3. Repair the external crack in the pre-cast panel with epoxy
4. Repair the cracks and settlement in the front deck (in front of the rugby change rooms)
5. Replace the external cladding above the concrete walls in the squash court – A painted plywood shadow clad may be considered where this is screwed in a bracing pattern to provide additional resistance to racking
6. Seal the wall joints between squash court and function area with a flexible sealant

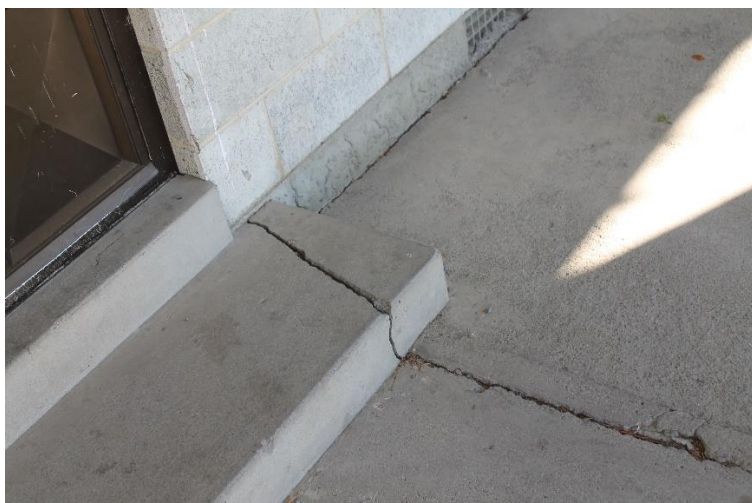
Crack through step at veranda

Cracks in veranda stair	Epoxy fill stair and grind flat		
Cracks in concrete floors in change rooms	Ensure floors are safe Grind and paint with epoxy nonslip floor coating		
Box gutter rust	Treat rust with rust converter and paint

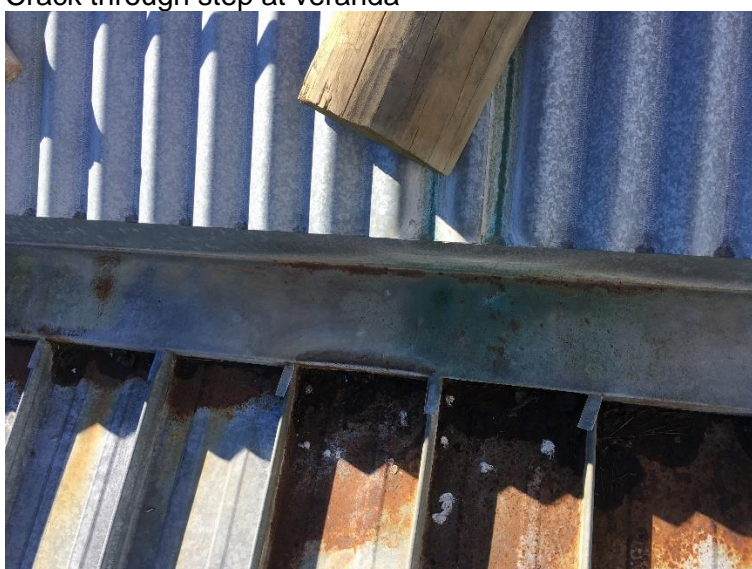
Rust on roof at box gutter

- Replace roof sheeting on the rugby change rooms with “long run” to repair the crushed sheet and ensure water proofing of the building
- Treat rust in box gutter – check on water proofing. Box Gutter is between the squash court roof and the main function area roof

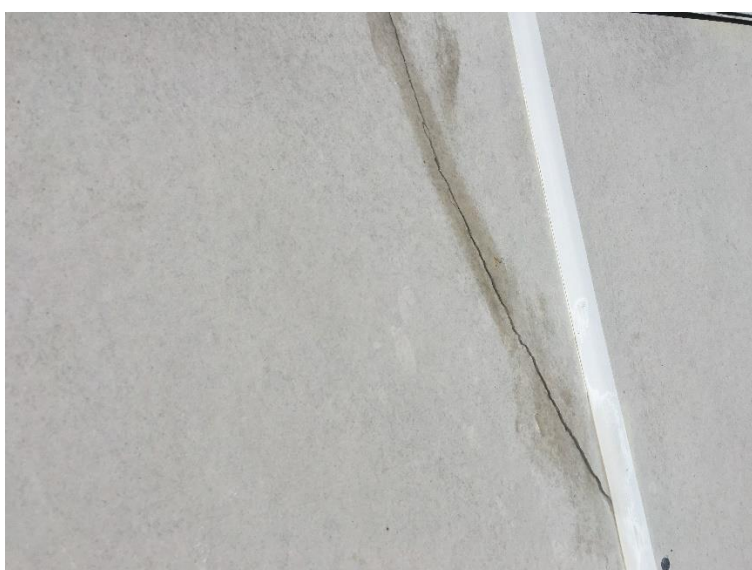
Crack through pp sheet at squash court – timber frame above concrete wall
