# Claverley Coastal Hazard Assessment Review

Document no: IZ128301-NM-RPT-0004  
Version: 0

Hurunui District Council

Hurunui District Coastal Hazards  
24 November 2023

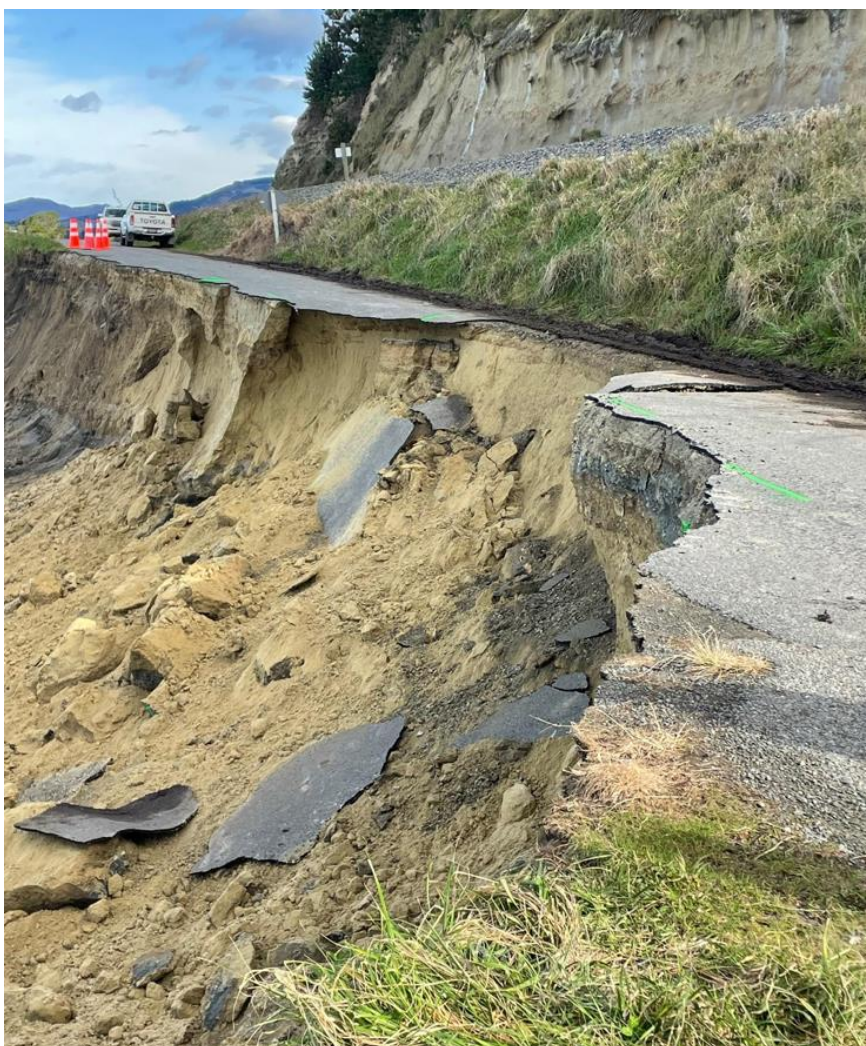
**Figure 2.1: Erosion and slope failure of Claverley Road. Photo taken on 13th July 2023.**

In July 2023 a slope failure in the road embankment backing the gravel beach system just north of the Claverley settlement occurred, resulting in 6 to 8 m of horizontal erosion along the Hurunui District Council (HDC) owned Claverley Road. This road runs adjacent to and provides lateral support for the rail embankment of the main trunk railway line. It is understood that the initial erosion occurred some time between the 8-11<sup>th</sup> July 2023, with continued gradual failure through to the 13<sup>th</sup> July, where in one section, the total width of the road was eroded (Figure 2.1).

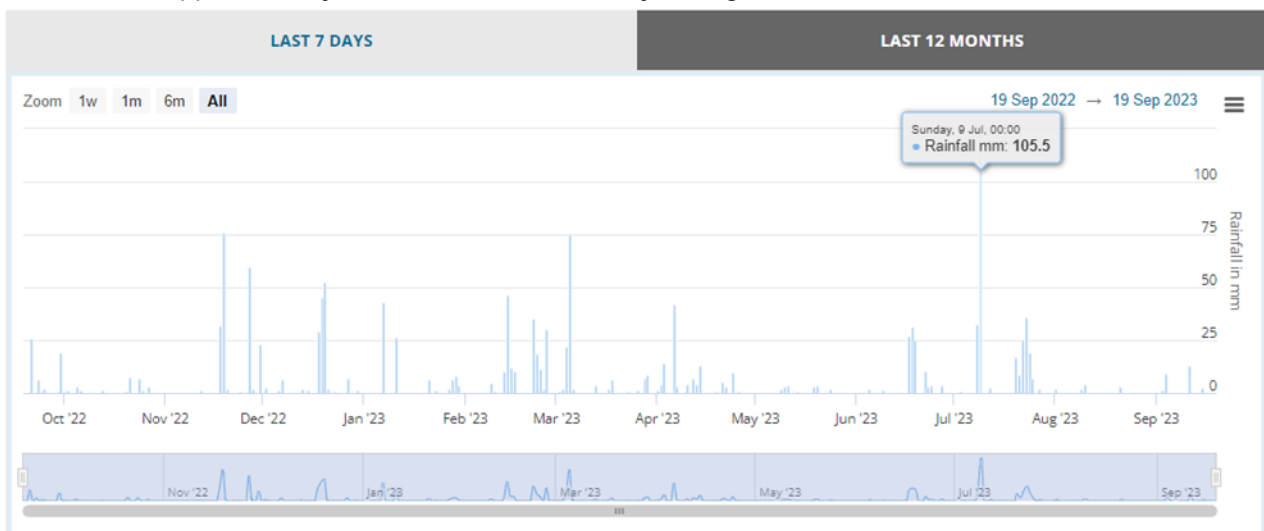
A heavy rainfall event occurred at Claverley on the 8<sup>th</sup>-9<sup>th</sup> July 2023, where 105.5 mm was recorded at the rainfall gauge at Tea Tree Terrace, approximately 15 km north of Claverley. This amount of rainfall is greater than the monthly average (90.9 mm) recorded since the site record began in 2011. This event was the third highest 24-hour rainfall on record, behind 146 mm (17/04/2014); and 301.5 mm (20/02/2018). On the day prior to this event (7<sup>th</sup> July), there was 33 mm of rain recorded, and in the month prior to the event, 142 mm was recorded (approximately 50 mm above the monthly average).

**Figure 2.2: Rainfall record for the 12 month period from September 2022-September 2023 for Tea Tree Terrace, a rainfall gauge located approximately 15 km north of Claverley. Record highlighted on 9th July 2023, which shows the peak rainfall reading over the past 12 months at 105.5 mm. Information sourced from Environment Canterbury.**

It is considered that antecedent rainfall conditions over the month prior to the failure event likely caused saturation of the road and rail embankment foundations, possibly contributing to the failure of the slope in the heavy rainfall event on the 8-9<sup>th</sup> July. Seepage into the road and rail embankment foundations is believed to have led to a reduction in strength of the foundation material, potentially contributing to the failure. However, there is not sufficient data to confirm the significance of this reduction in strength of the foundation

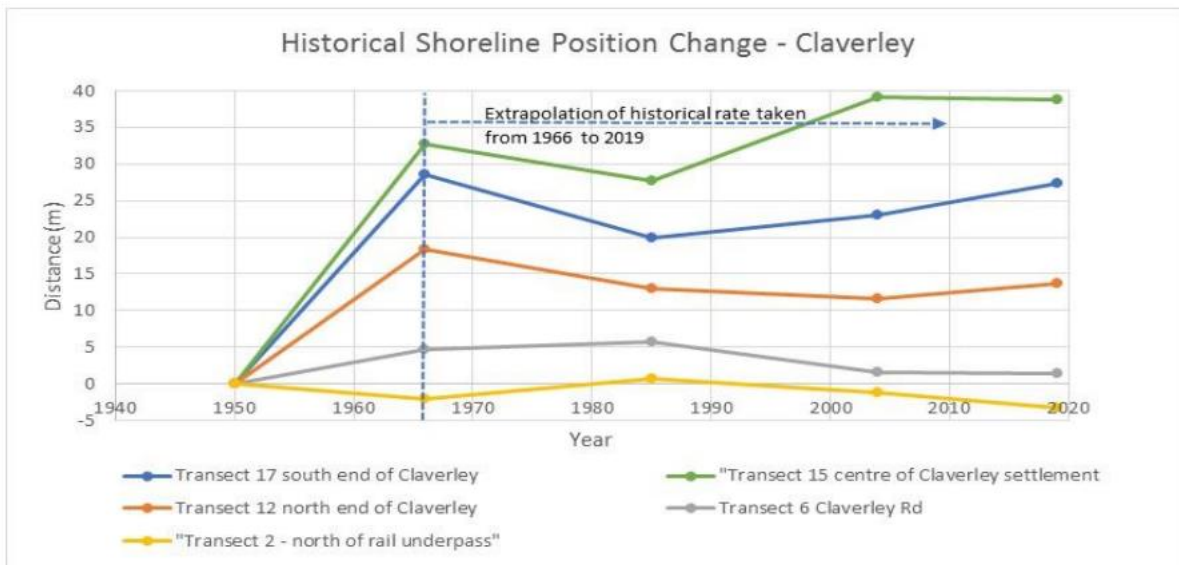
Figure 3.2: Historical shoreline position change at Claverley from Jacobs (2020).

The Jacobs (2020) assessment analysed five aerial photographs between 1950 and 2019. Figure 3.2 shows the historical trends identified from these images. The assessment showed that all transects along the frontage of the settlement had experienced net accretion since 1950, however areas north of the rail underpass, and the shoreline along Claverley Road had been generally stable/slightly erosional. A review of the aerial imagery suggests that the magnitude of failure that occurred along the road in July 2023 had not been observed before along this section of coast. However, failure of a smaller and undetectable magnitudes could have occurred, or failure which was followed by repair between aerial images being taken.
